### Inspection Report

#### Minerals Regulatory Program

**Mine Name:** ECDC Clay Mine

**Permit number:** M/015/062

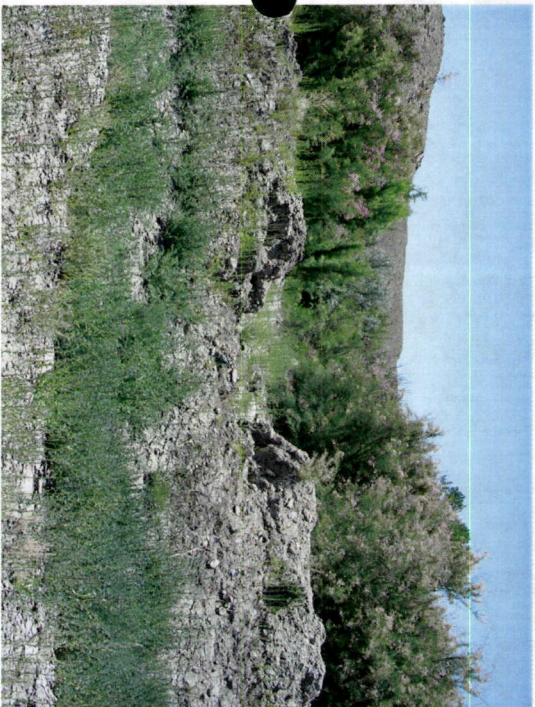
There is a berm separating much of the site from the Price River, but at the bottom of the hill from the entrance gate, there is an area where the berm has been breached (Photos 1 and 2). This needs to be repaired, and the operator may want to consider an alternative other than just building up the berm. It might be good to install a notched, wire-reinforced silt fence to allow some discharge while still controlling sediment.

**Photo 1. A breach in the berm near the bottom of the hill by the entrance gate.**

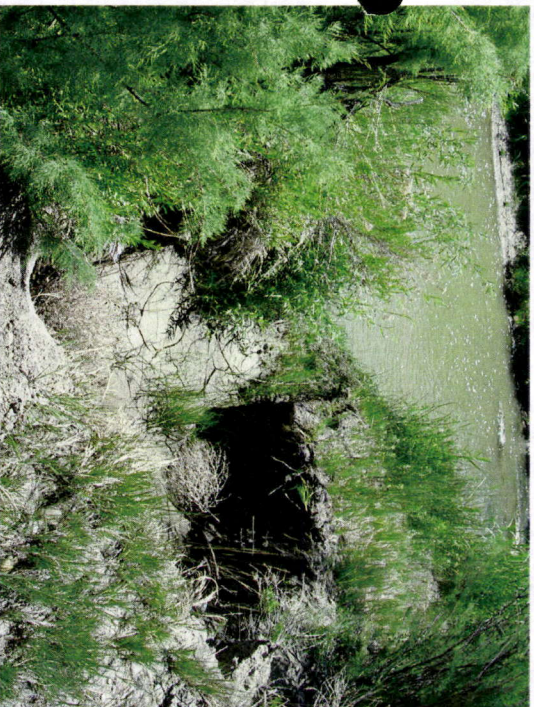
**Photo 2. This is where water flows into the Price River after going through the breach shown in Photo 1.**

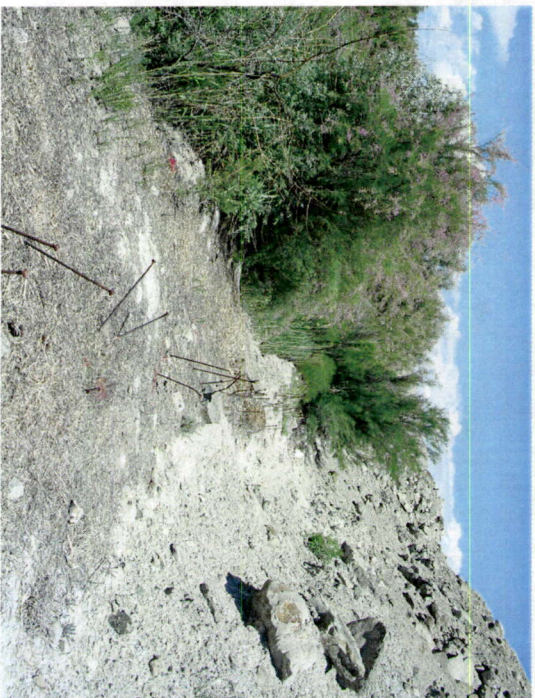
In 2001, I asked the operator to install sediment control along a section of an overburden pile, and a row of straw bales was placed along the base of this pile. These bales have deteriorated and probably control little sediment (Photo 3). Although I considered asking the operator to maintain these straw bales, the overburden pile and adjacent riparian area look almost identical to a nearby undisturbed area (Photo 4). Therefore, I do not feel there is a need to maintain the straw bales, but the Division and the operator should monitor this area for accelerated erosion and sediment additions to the river.

**Photo 3. The remains of straw bales along the overburden/spoil pile.**

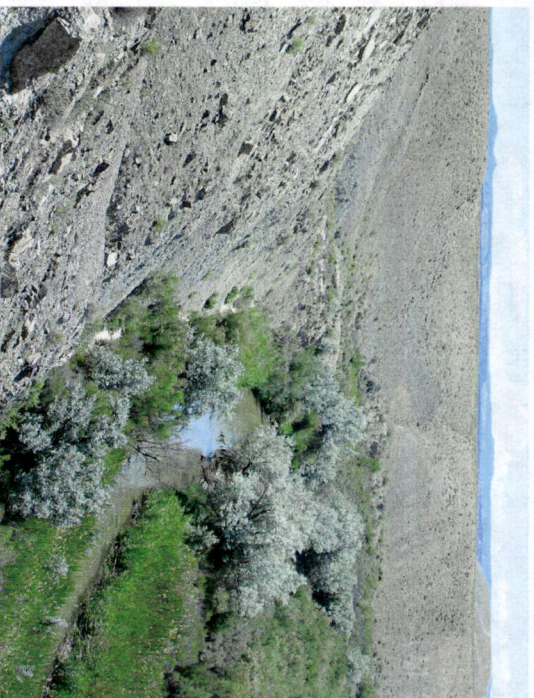
**Photo 4. A nearby undisturbed area with a nearly-barren slope ending at the riparian area next to the river.**

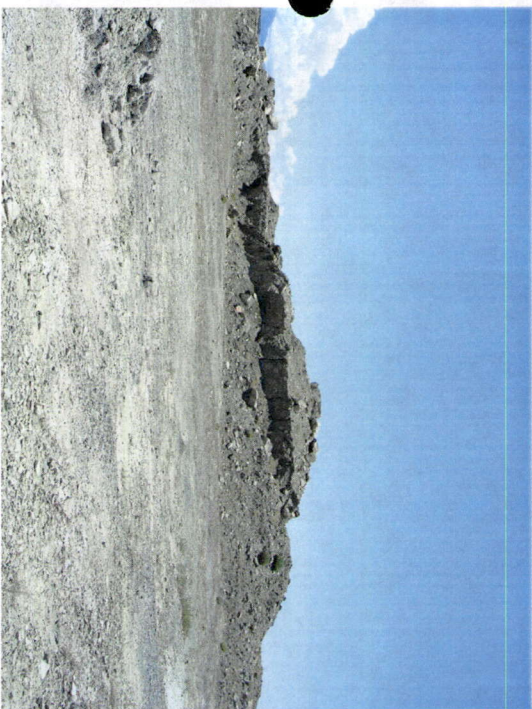
The soil pile is shown in Photo 5. The operator needs to ensure that this material is not used for anything other than reclamation, and I suggest putting a sign on the pile advising people that it is topsoil. I also suggest that the operator try to establish vegetation on this pile. The next time equipment is brought to the mine, the pile could be worked so it is very rough without the near-vertical slopes. It could then be seeded.

**Photo 5. The topsoil stockpile.**

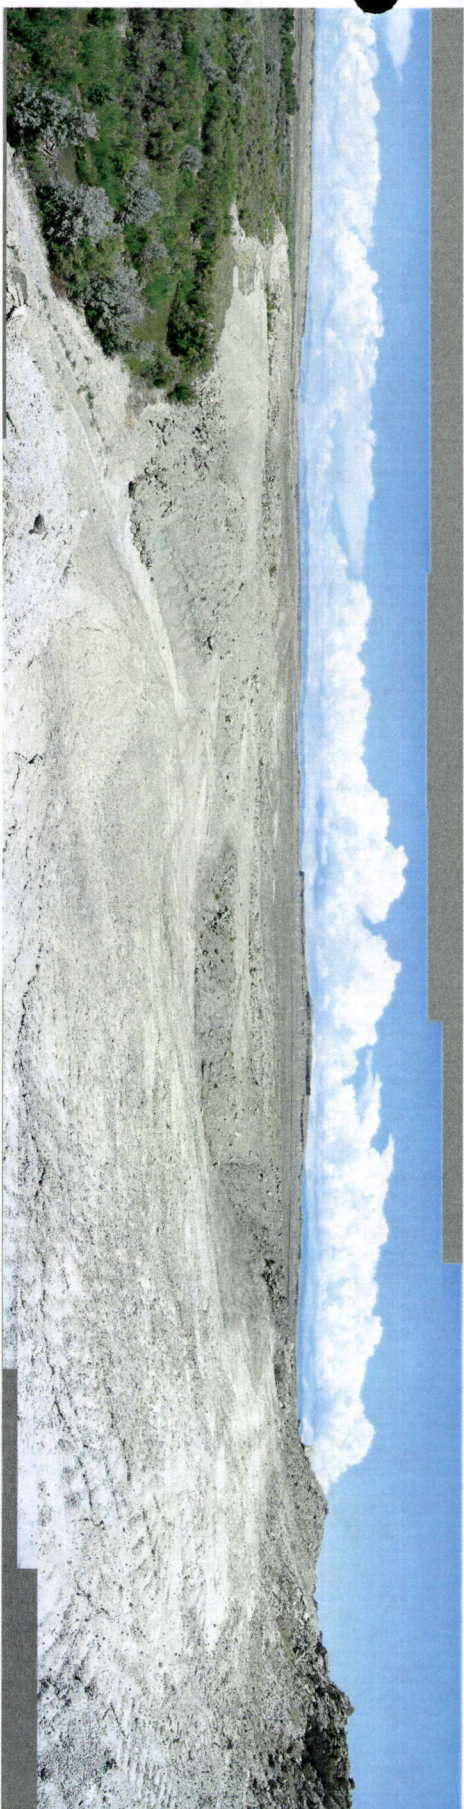
**Photo 6. A panorama taken from the southeast part of the site. The straw bales in Photo 3 are in the left center of this photo.**
